LETTER REPORT
FOR
BOWERS BATTERY SITE
NEW PHILADELPHIA, TUSCARAWAS COUNTY, OHIO
TDD: S05-0010-022
PAN: 0C2201SIXX
START DOCUMENT CONTROL NUMBER: START-05-23-050132

Re: Bowers Battery Site
New Philadelphia, Tuscarawas County, Ohio
TDD: S05-0010-022
PAN: 0C2201SIXX

Attachment D
Photodocumentation

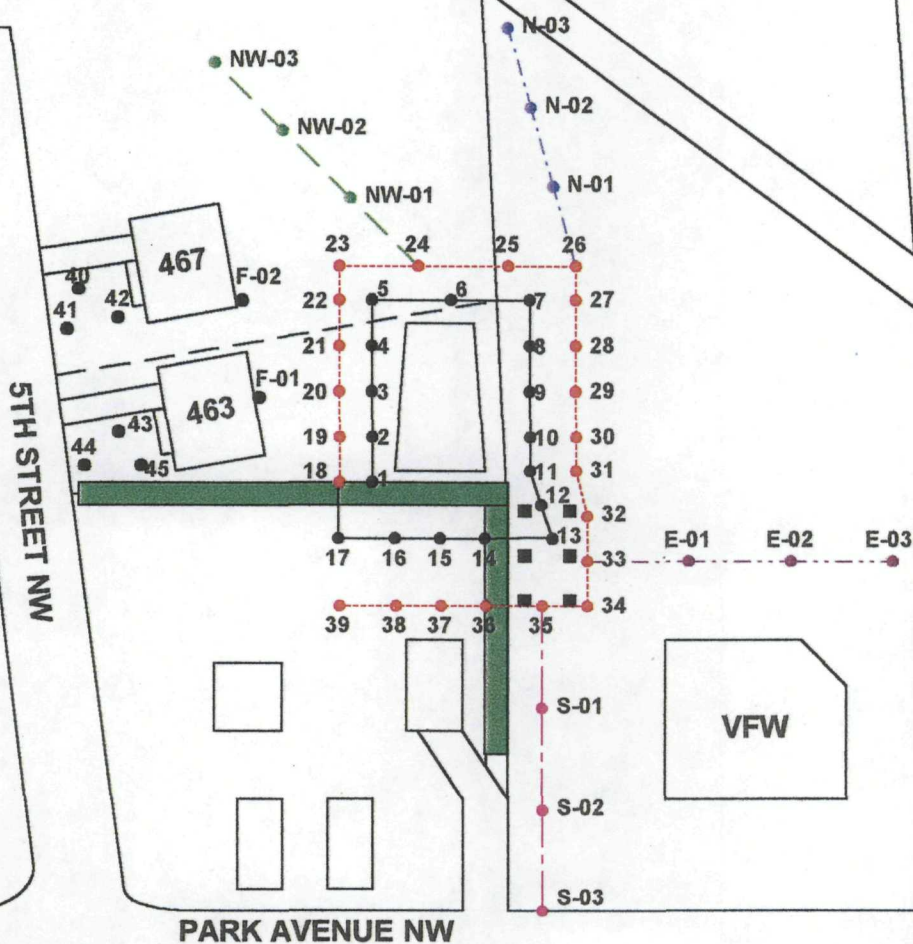
TITLE:	Site Features and Sampling Map	ATTACHMENT:	B
SITE:	Bowers Battery Site	SCALE:	Not to scale
CITY:	New Philadelphia	STATE:	Ohio
SOURCE:	USGS Topographic Map 7.5' Series New Philadelphia Quadrangle Ohio-Tuscarawas County	TDD:	S05-0010-022
		DATE:	1962
		REVISED:	1985

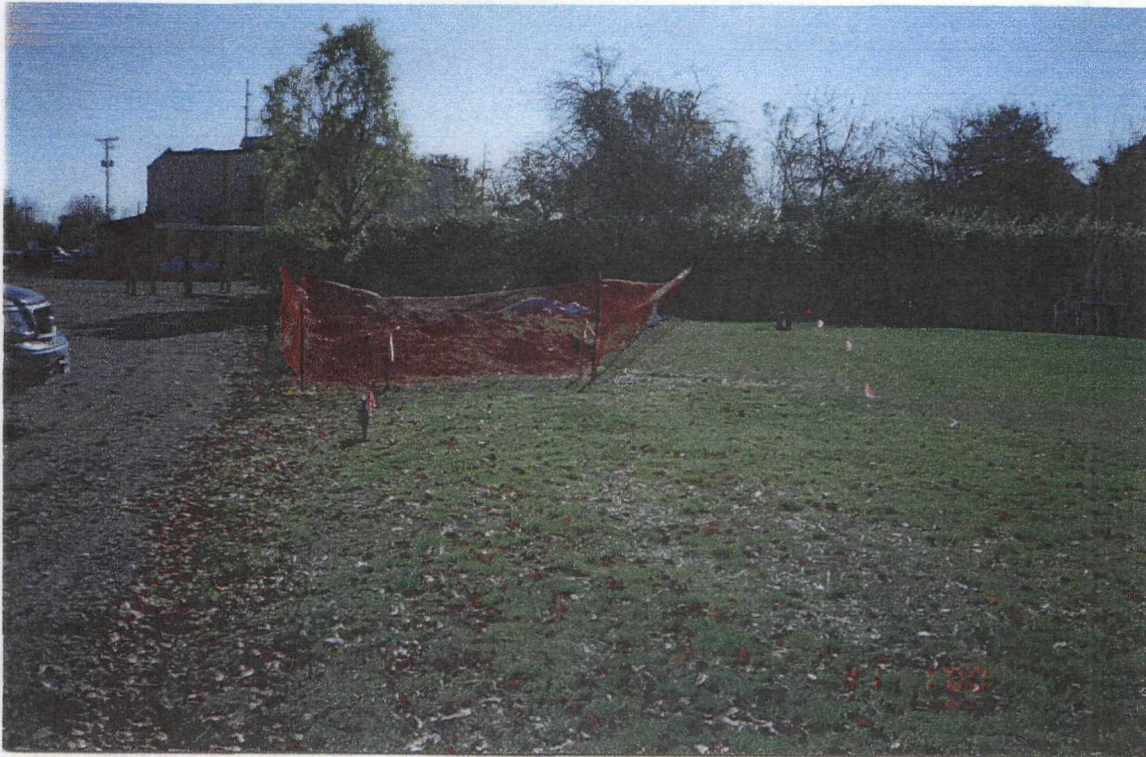
SITE: Bowers Battery **TDD:** S05-0010-022 **PAN:** 0C2201SIXX **PHOTO:** 1
DATE: November 1, 2000 **DIRECTION:** South **PHOTOGRAPHER:** D. Pearce
SUBJECT: View of the overturned soil and the first six soil sampling locations in the back yards of 463 and 467 5th Street NW.

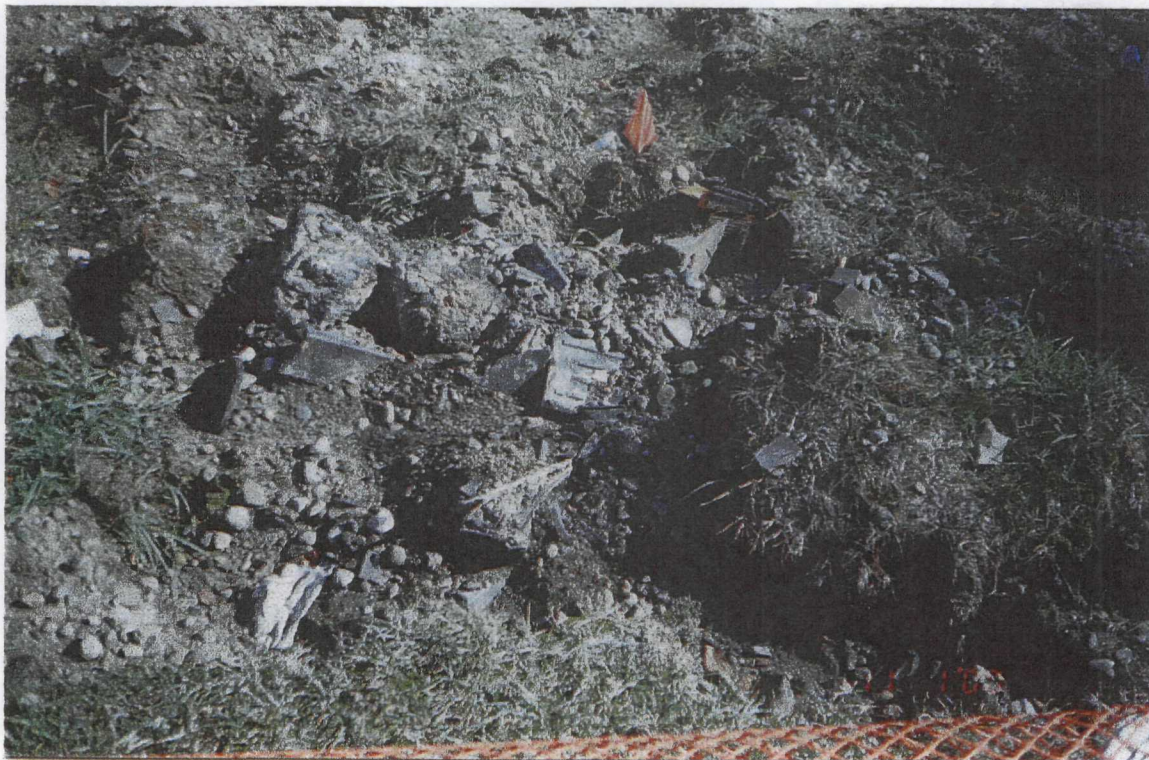
SITE: Bowers Battery **TDD:** S05-0010-022 **PAN:** 0C2201SIXX **PHOTO:** 2
DATE: November 1, 2000 **DIRECTION:** N/A **PHOTOGRAPHER:** D. Pearce
SUBJECT: View of the buried car batteries found in the back yard of 463 5th Street NW located in New Philadelphia, Ohio.

The resident at 463 5th Street NW observed the buried car batteries when a backhoe was utilized to overturn soil in his back yard in order to put in a garden. The Bowers Battery Company was previously located on the property of VFW Post 1445. The VFW Club occupies the only building that still remains on this property.

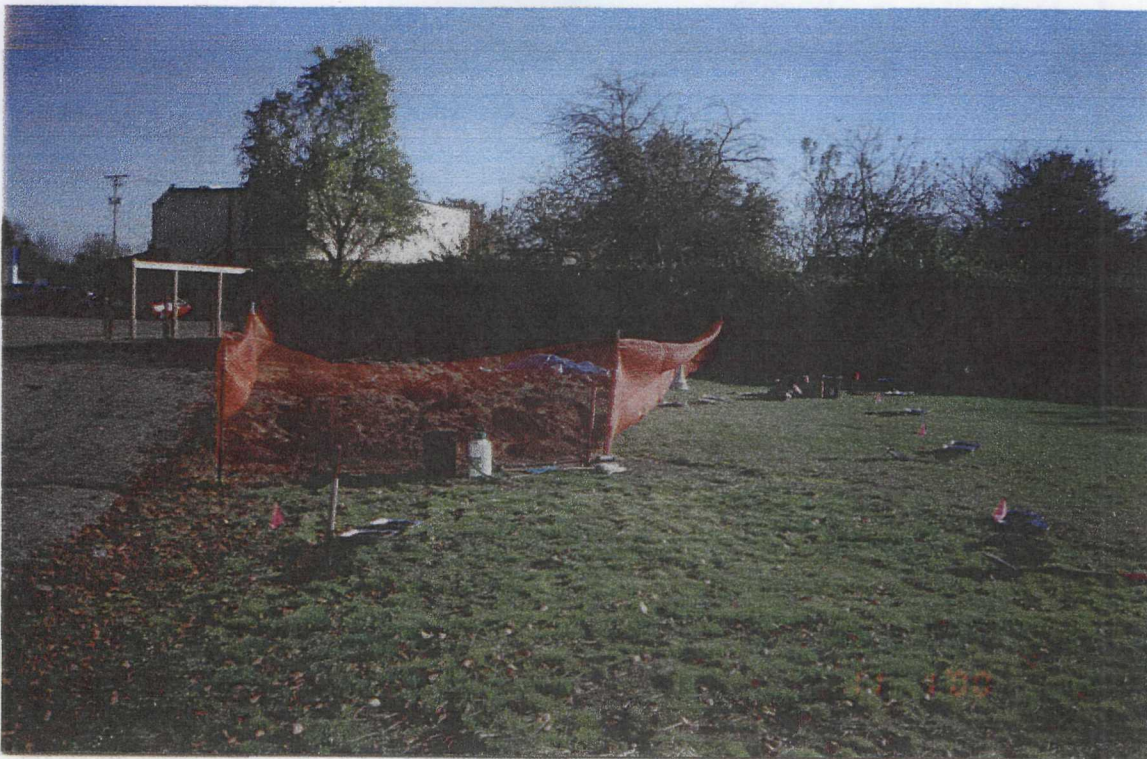
SITE: Bowers Battery **TDD:** S05-0010-022 **PAN:** 0C2201SIXX **PHOTO:** 3
DATE: November 1, 2000 **DIRECTION:** South **PHOTOGRAPHER:** D. Pearce
SUBJECT: View of the overturned soil and the first six soil sampling locations in the back yards of 463 and 467 5th Street NW.

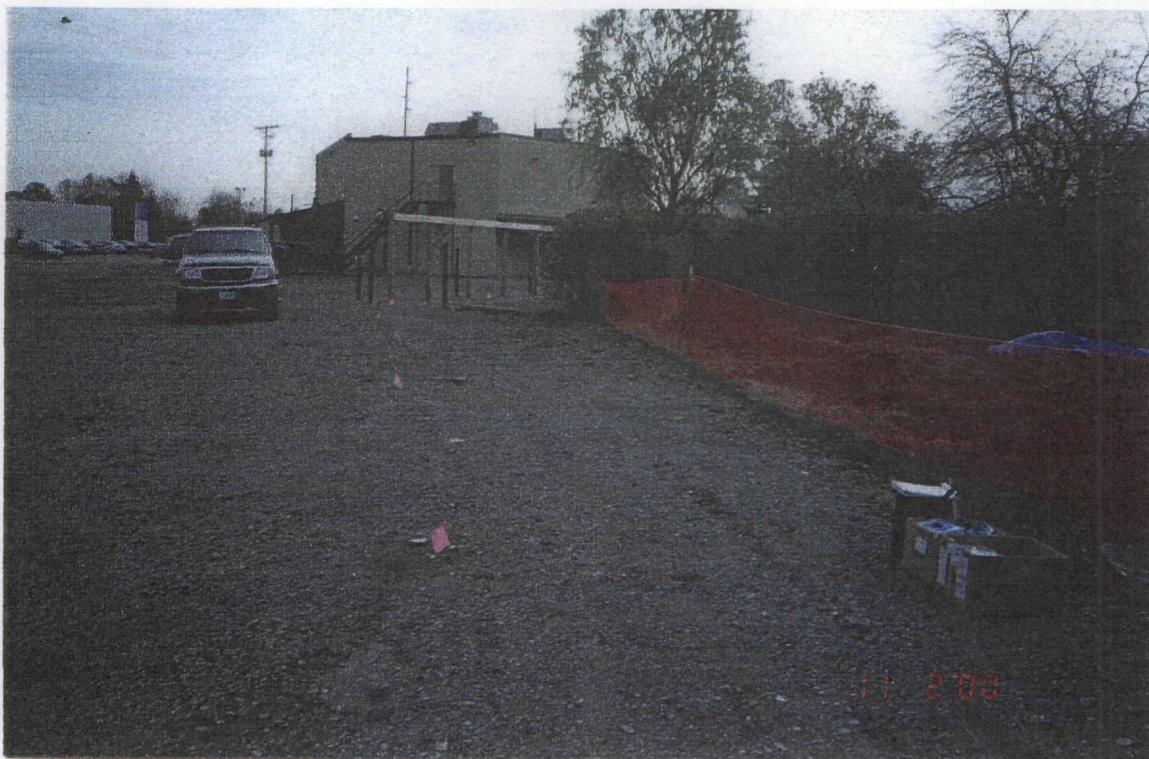
SITE: Bowers Battery **TDD:** S05-0010-022 **PAN:** 0C2201SIXX **PHOTO:** 4
DATE: November 1, 2000 **DIRECTION:** South **PHOTOGRAPHER:** D. Pearce
SUBJECT: View of the rear gravel parking lot for VFW Post 1445 and soil sampling locations PL-07 through PL-13.

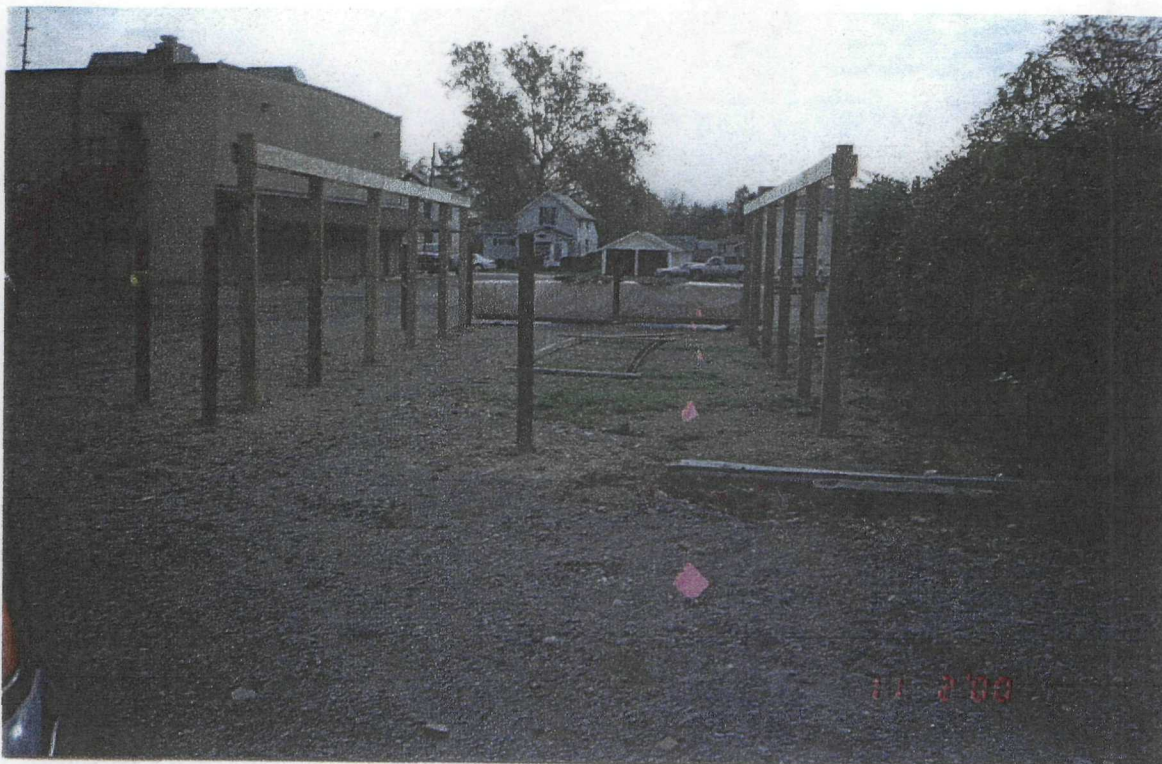
SUBJECT: View of the support posts of the planned BBQ shelter for the VFW Club in the rear gravel parking lot.

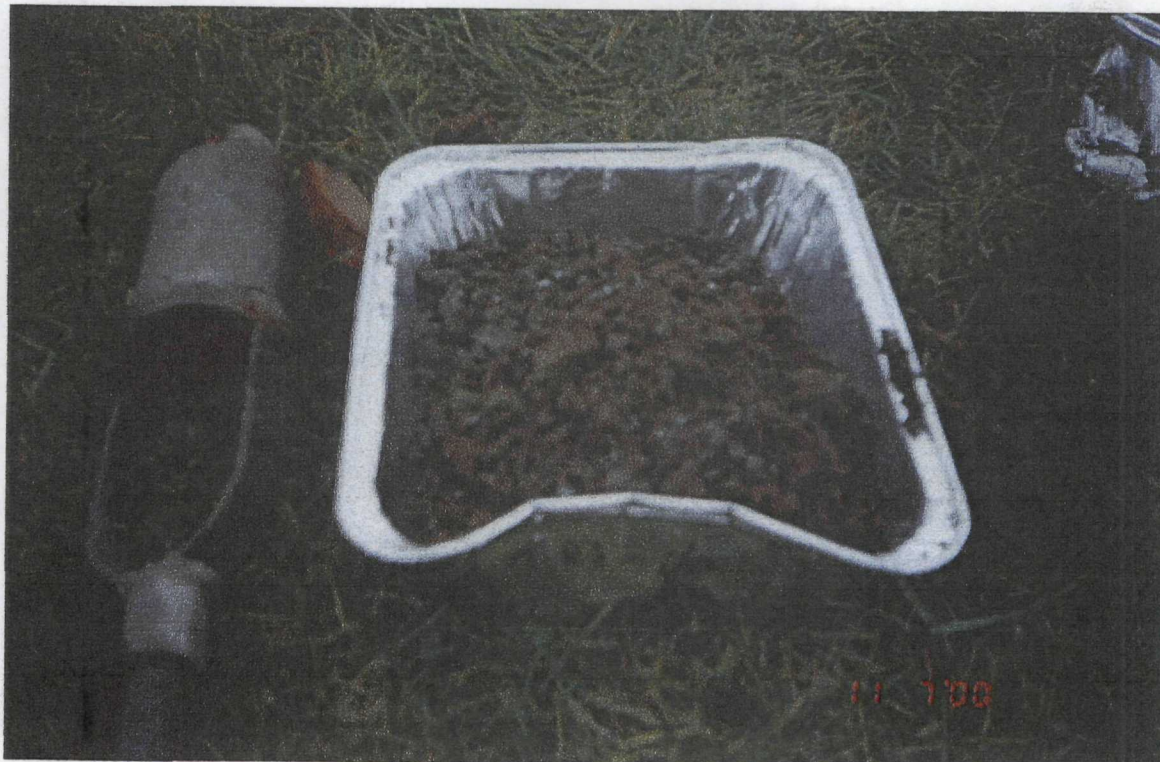
SUBJECT: View of soil sample BB-RS-03C in the back yard of 463 5th Street NW. (Note green-colored deposits in soil.)

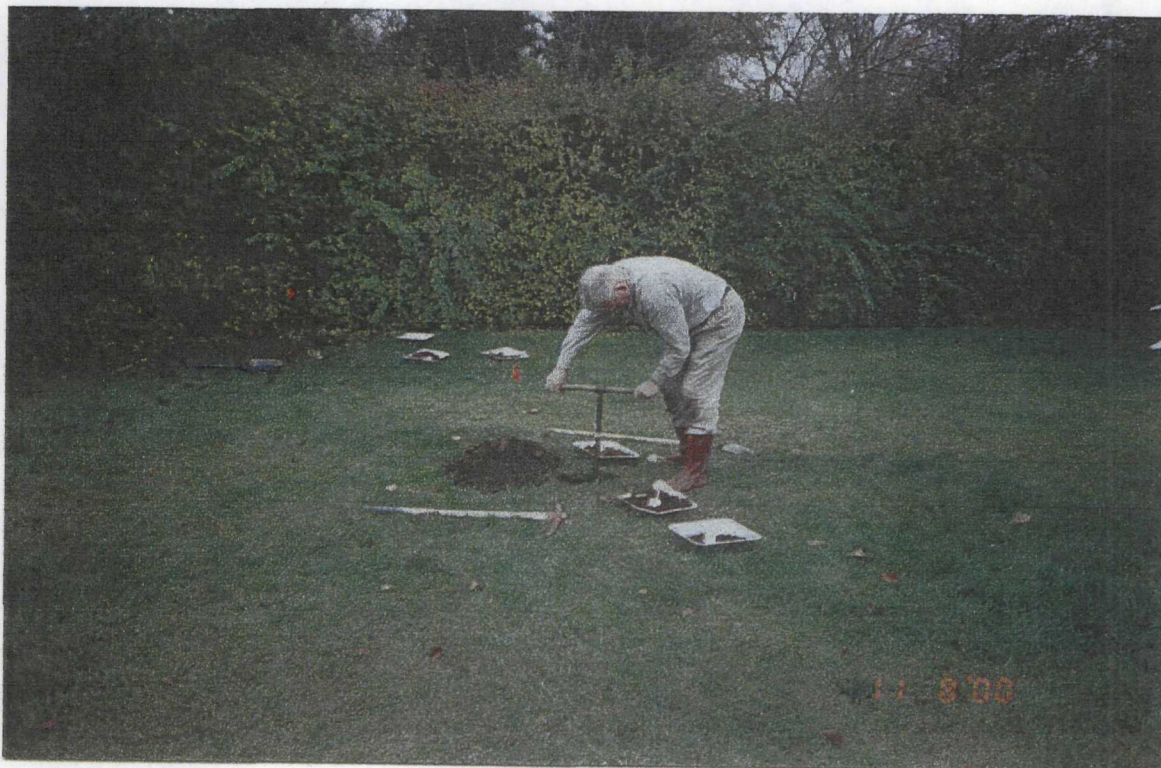
SUBJECT: View of START member utilizing a hand auger to collect soil from the "C" level at sampling location RS-19.

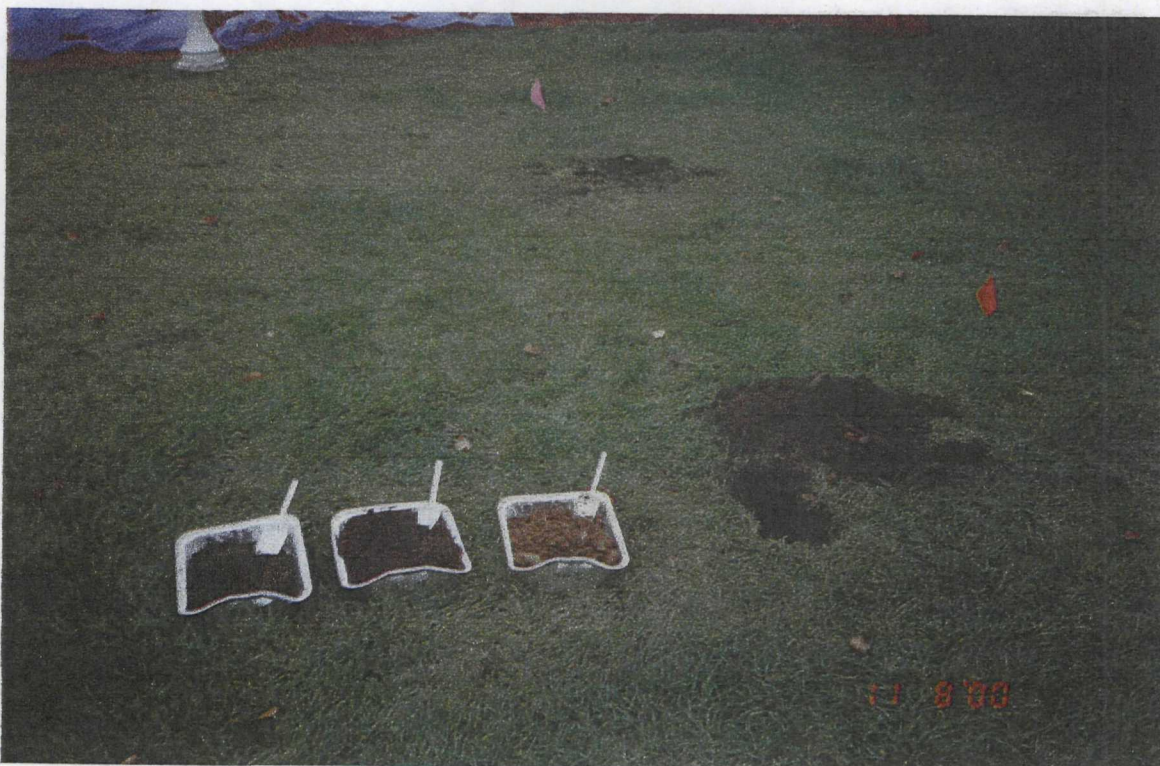
SUBJECT: View of soil samples BB-RS-19A, B, and C in the back yard of 463 5th Street NW.

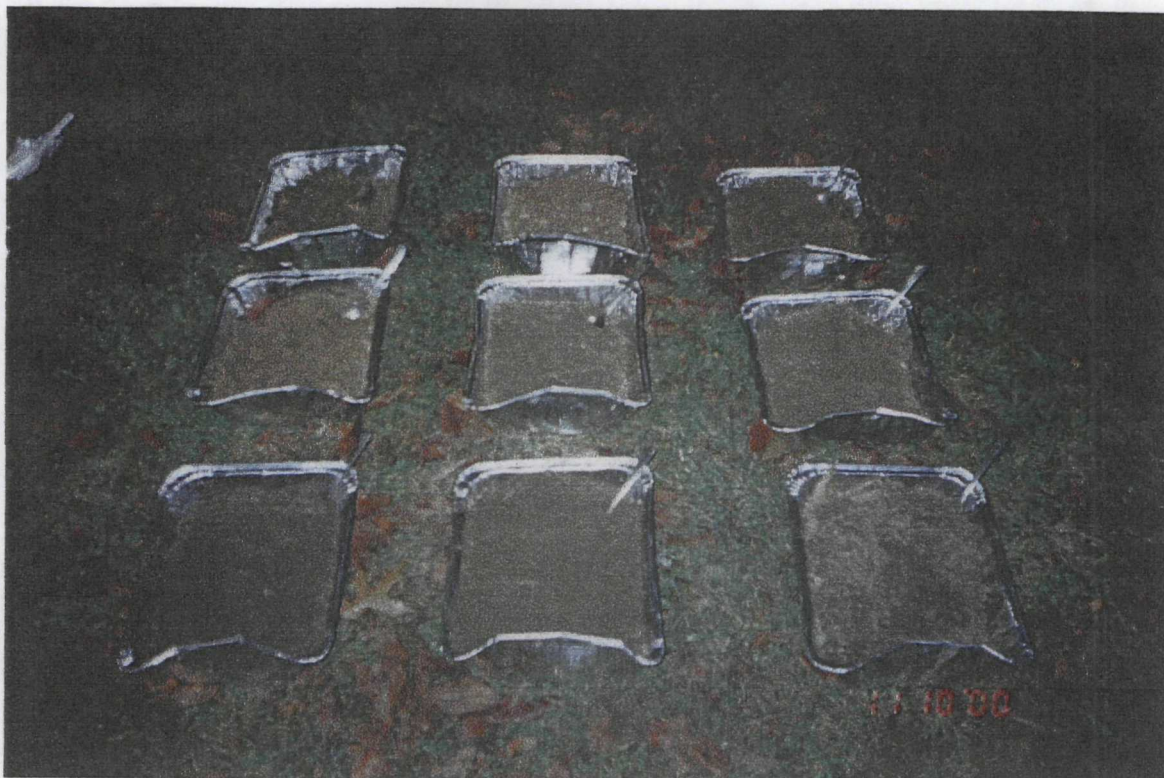
SITE: Bowers Battery **TDD:** S05-0010-022 **PAN:** 0C2201SIXX **PHOTO:** 9
DATE: November 10, 2000 **DIRECTION:** N/A **PHOTOGRAPHER:** D. Pearce
SUBJECT (Right to left): Soil samples BB-RS-40A,B,C; BB-RS-41A,B,C; and BB-RS-42A,B,C. (Front: Level A, Middle: Level B, Back: Level C.)

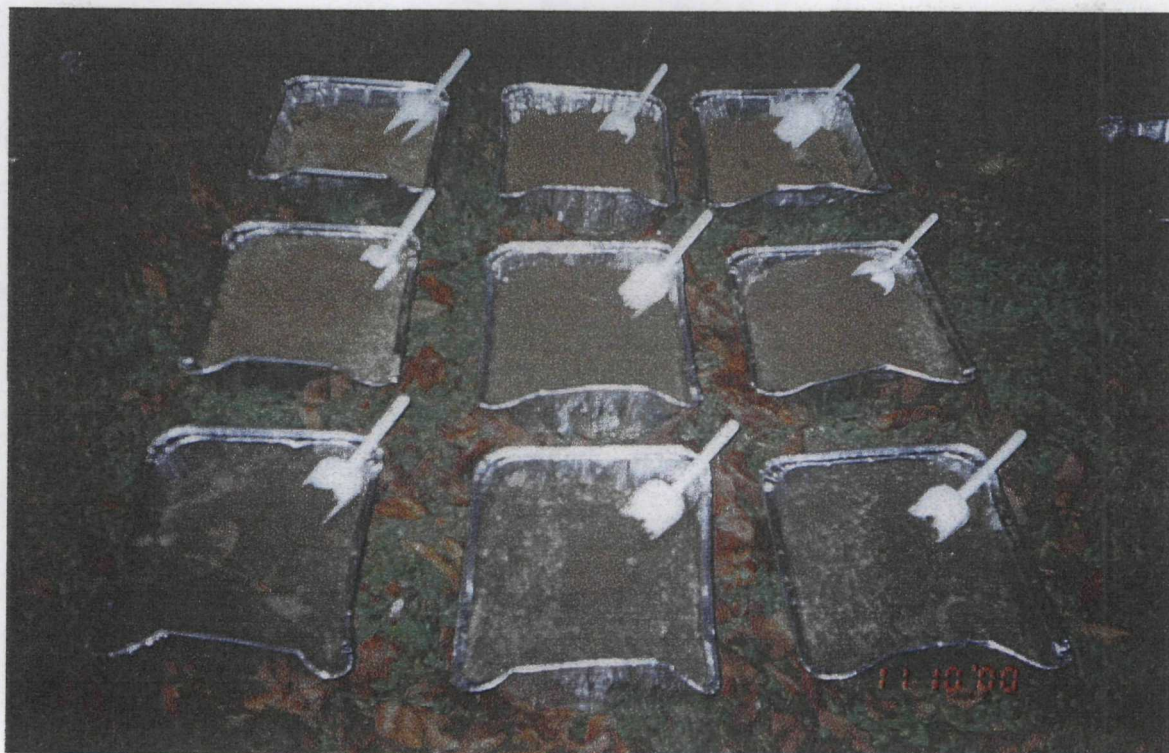
SITE: Bowers Battery **TDD:** S05-0010-022 **PAN:** 0C2201SIXX **PHOTO:** 10
DATE: November 10, 2000 **DIRECTION:** N/A **PHOTOGRAPHER:** D. Pearce
SUBJECT (Right to left): Soil samples BB-NW-01A,B,C; BB-NW-02A,B,C; and BB-NW-03A,B,C. (Front: Level A, Middle: Level B, Back: Level C.)

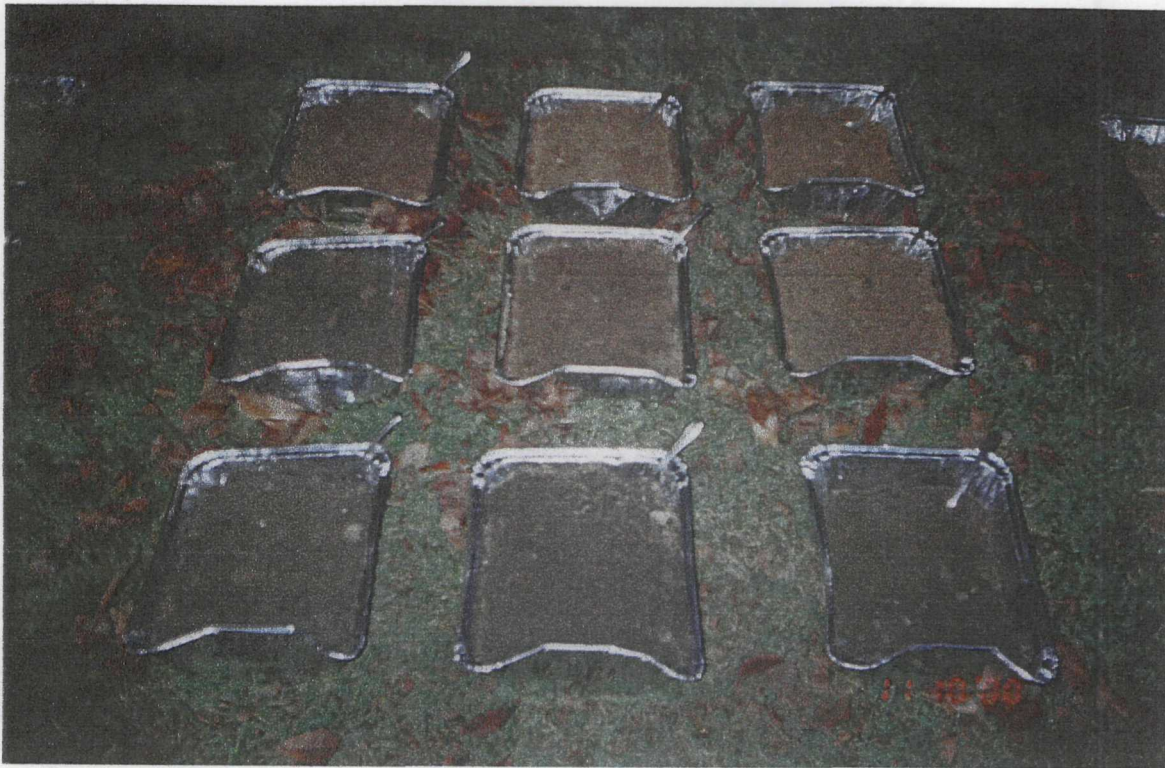
SITE: Bowers Battery **TDD:** S05-0010-022 **PAN:** 0C2201SIXX **PHOTO:** 11
DATE: November 10, 2000 **DIRECTION:** N/A **PHOTOGRAPHER:** D. Pearce
SUBJECT (Right to left): Soil samples BB-E-01A,B,C; BB-E-02A,B,C; and BB-E-03A,B,C. (Front: Level A, Middle: Level B, Back: Level C.)

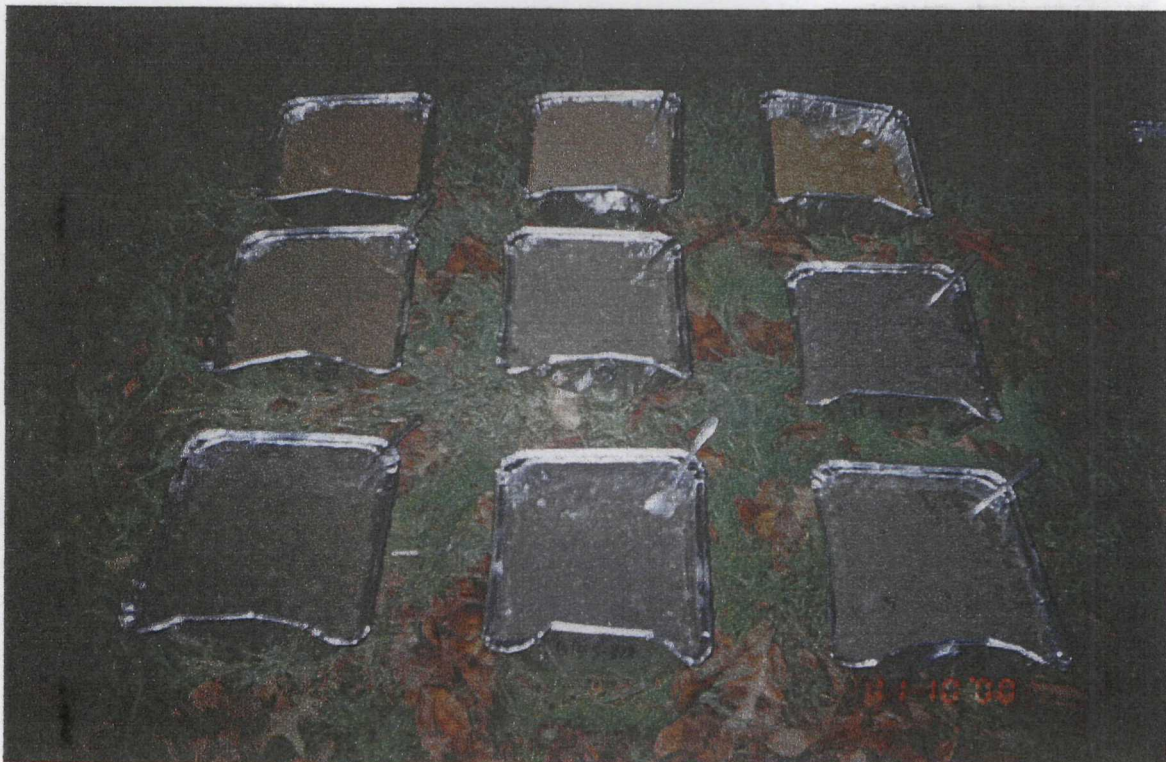
SITE: Bowers Battery **TDD:** S05-0010-022 **PAN:** 0C2201SIXX **PHOTO:** 12
DATE: November 10, 2000 **DIRECTION:** N/A **PHOTOGRAPHER:** D. Pearce
SUBJECT (Right to left): Soil samples BB-S-01A,B,C; BB-S-02A,B,C; and BB-S-03A,B,C. (Front: Level A, Middle: Level B, Back: Level C.)

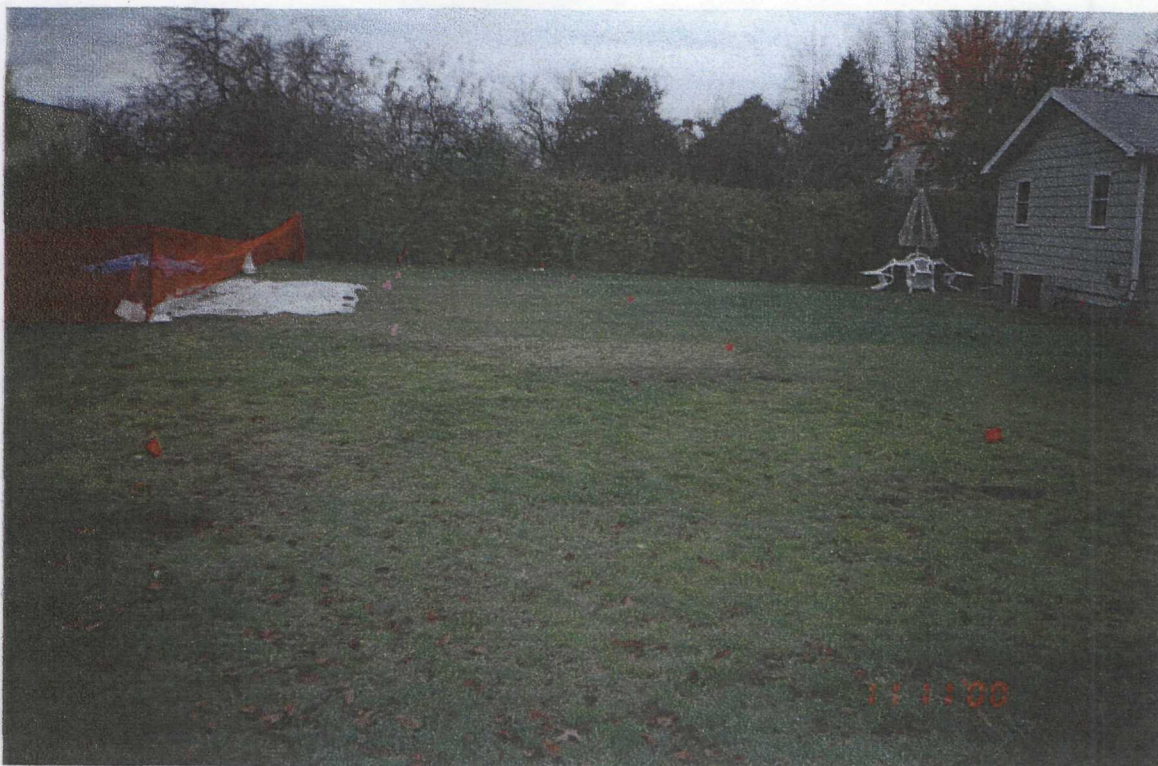
SITE: Bowers Battery **TDD:** S05-0010-022 **PAN:** 0C2201SIXX **PHOTO:** 13
DATE: November 11, 2000 **DIRECTION:** South **PHOTOGRAPHER:** D. Pearce
SUBJECT: View of the first (pink flags) and second (red flags) "rings" of soil sampling locations in the back yards of 463 and 467 5th Street NW.

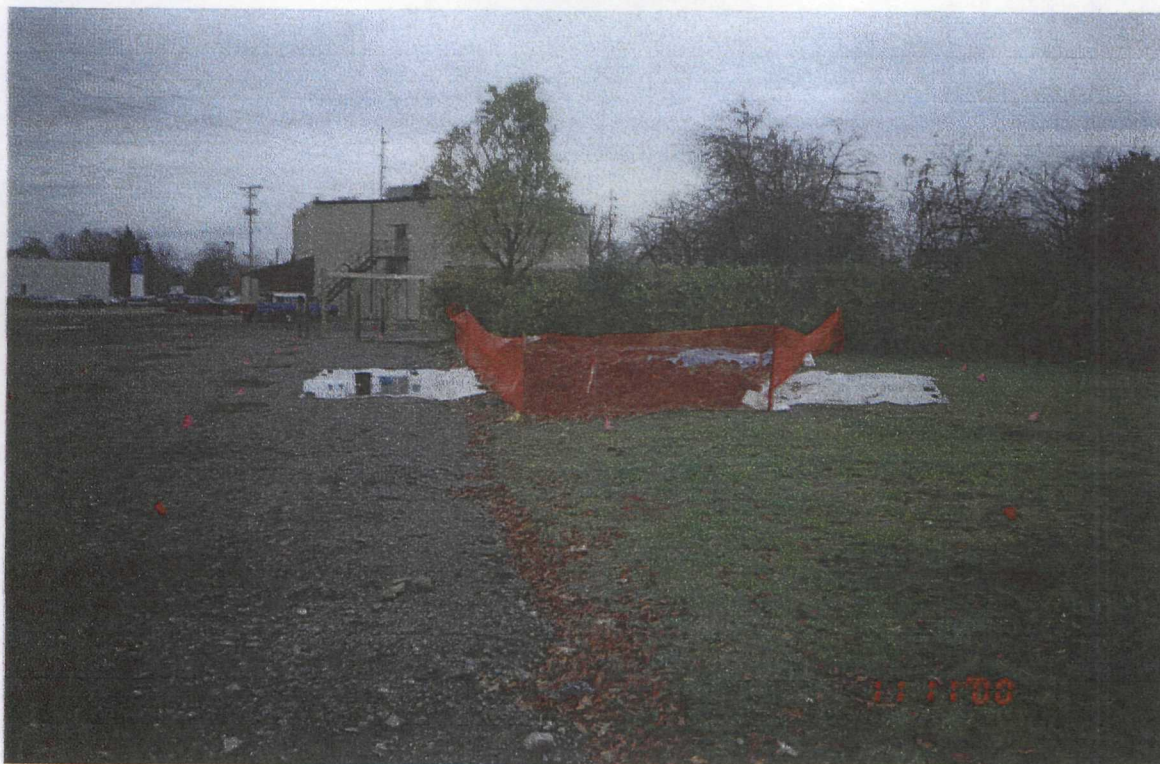
SITE: Bowers Battery **TDD:** S05-0010-022 **PAN:** 0C2201SIXX **PHOTO:** 14
DATE: November 11, 2000 **DIRECTION:** South **PHOTOGRAPHER:** D. Pearce
SUBJECT: View of the first (pink flags) and second (red flags) "rings" of soil sampling locations in the back yards of 463 and 467 5th Street NW and the VFW Post 1445 parking lot.

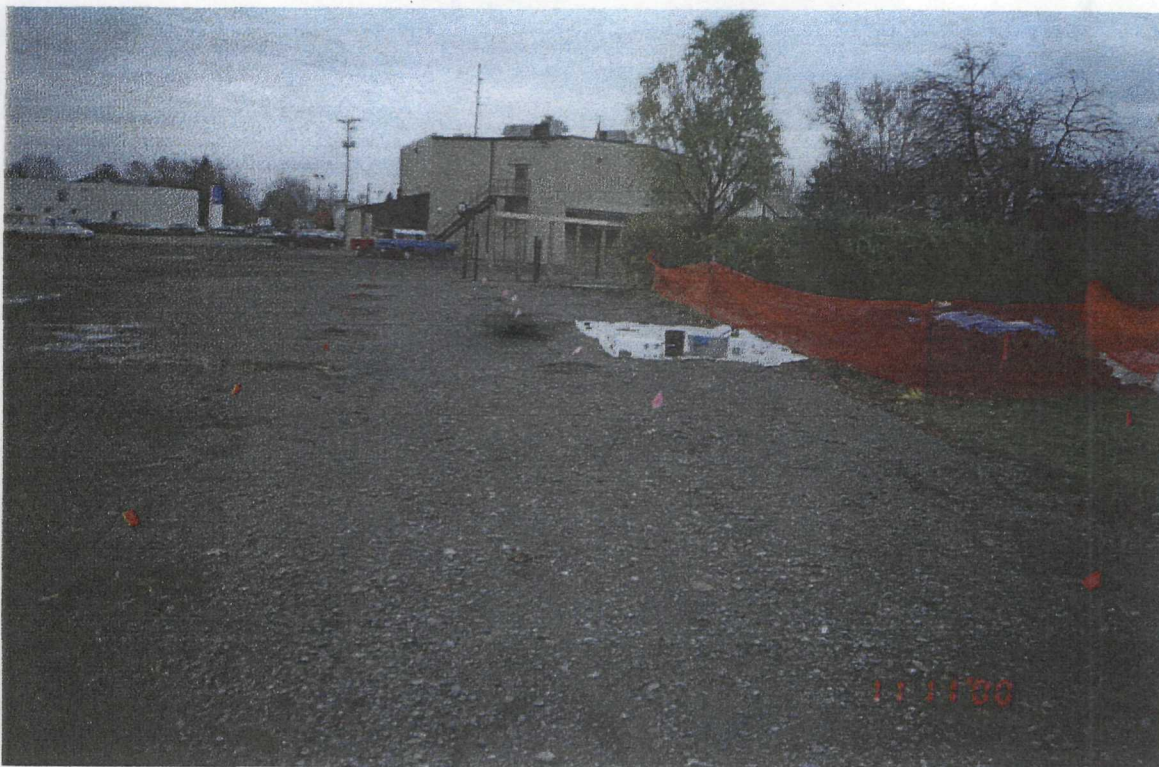
SITE: Bowers Battery **TDD:** S05-0010-022 **PAN:** 0C2201SIXX **PHOTO:** 15
DATE: November 11, 2000 **DIRECTION:** South **PHOTOGRAPHER:** D. Pearce
SUBJECT: View of the first (pink flags) and second (red flags) "rings" of soil sampling locations in the VFW Post 1445 parking lot.

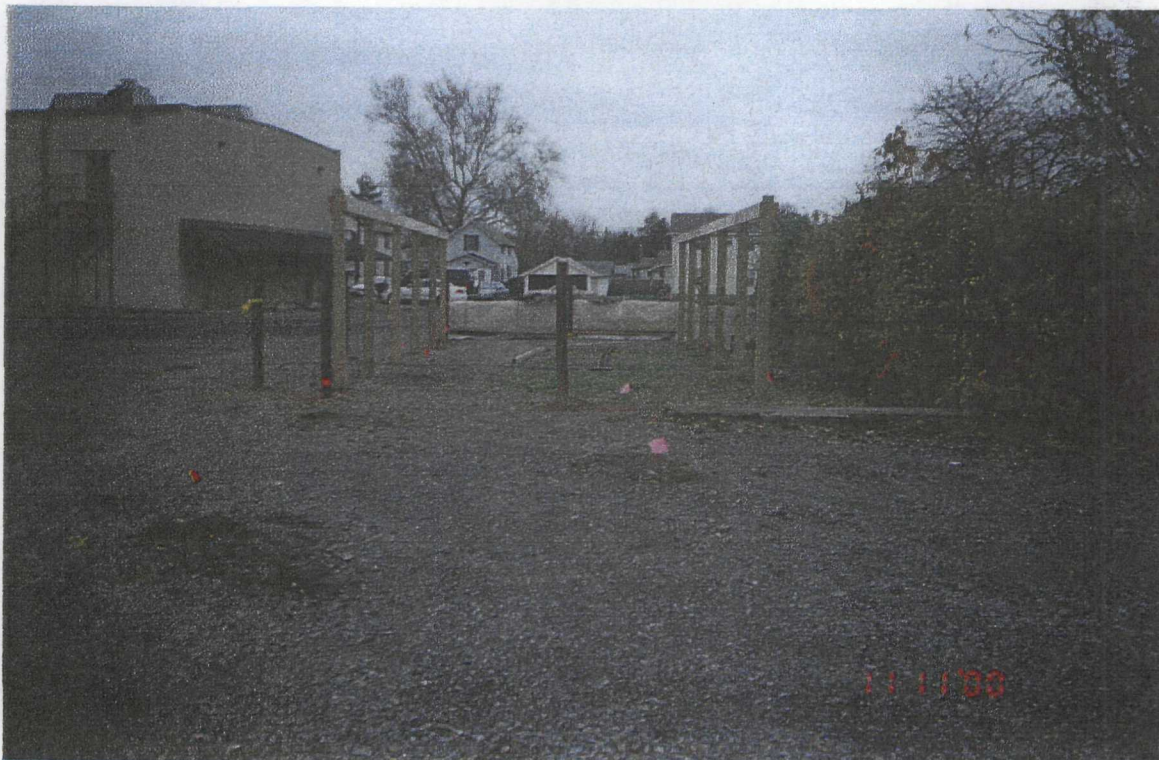
SITE: Bowers Battery **TDD:** S05-0010-022 **PAN:** 0C2201SIXX **PHOTO:** 16
DATE: November 11, 2000 **DIRECTION:** South **PHOTOGRAPHER:** D. Pearce
SUBJECT: View of the first (pink flags) and second (red flags) "rings" of soil sampling locations in the VFW Post 1445 parking lot.

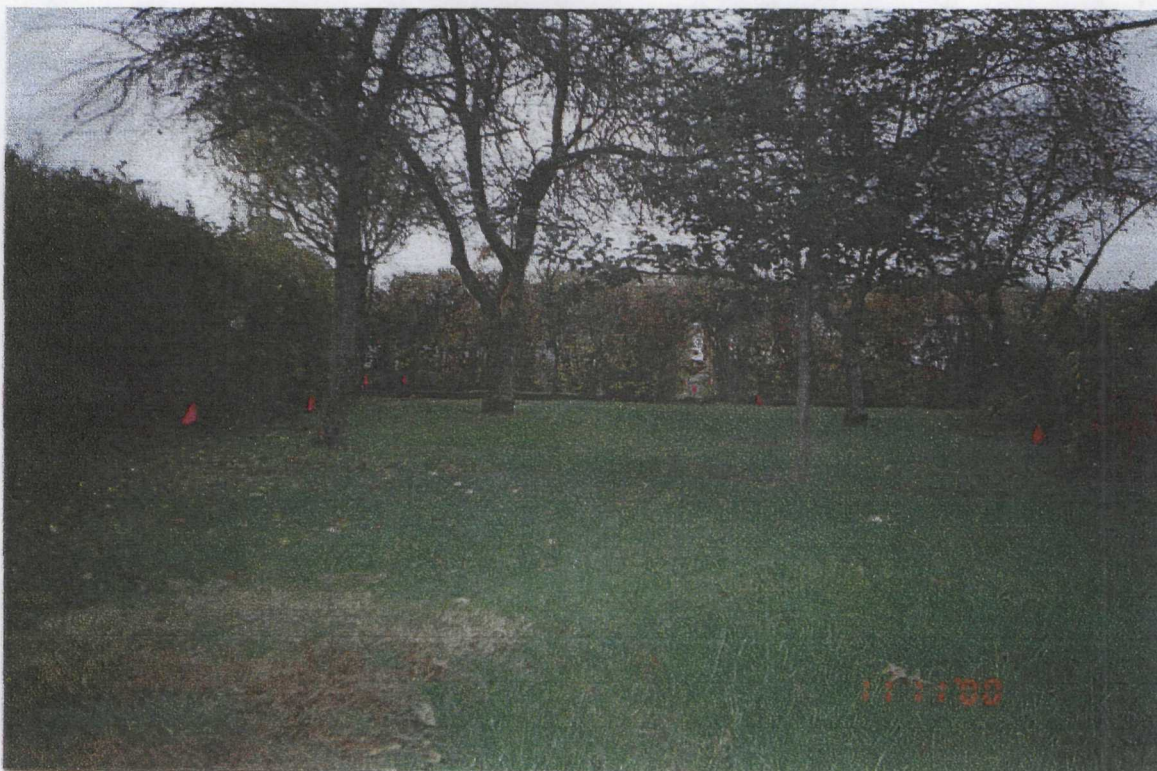
SITE: Bowers Battery **TDD:** S05-0010-022 **PAN:** 0C2201SIXX **PHOTO:** 17
DATE: November 11, 2000 **DIRECTION:** East **PHOTOGRAPHER:** D. Pearce
SUBJECT: View of the back yard of 467 Park Avenue NW. The last four locations for both the first (pink) and second (red) "rings" of soil sampling locations surrounding the overturned soil are indicated by the flags.

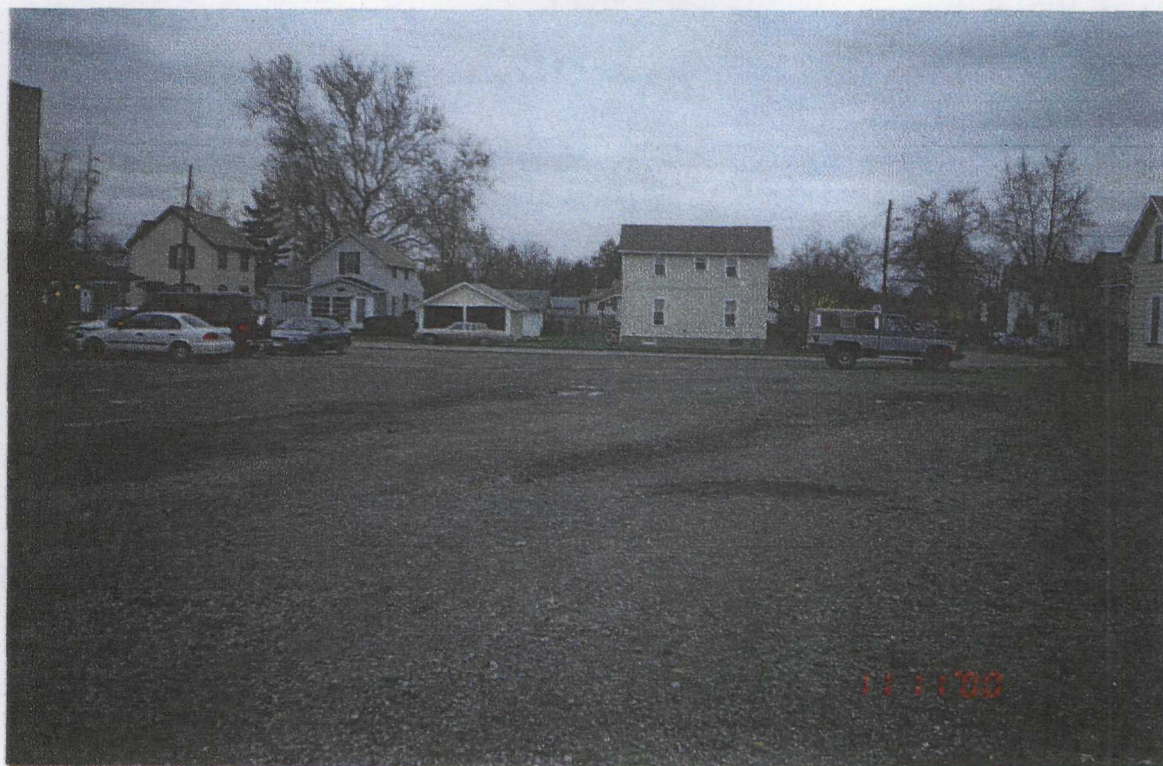
SITE: Bowers Battery **TDD:** S05-0010-022 **PAN:** 0C2201SIXX **PHOTO:** 18
DATE: November 11, 2000 **DIRECTION:** South **PHOTOGRAPHER:** D. Pearce
SUBJECT: View of the south transect (sampling locations S-01, S-02, and S-03) which runs from BB-PL-35 at the VFW BBQ shelter to just before Park Avenue at the VFW entrance. This transect is approximately 200 feet in length.

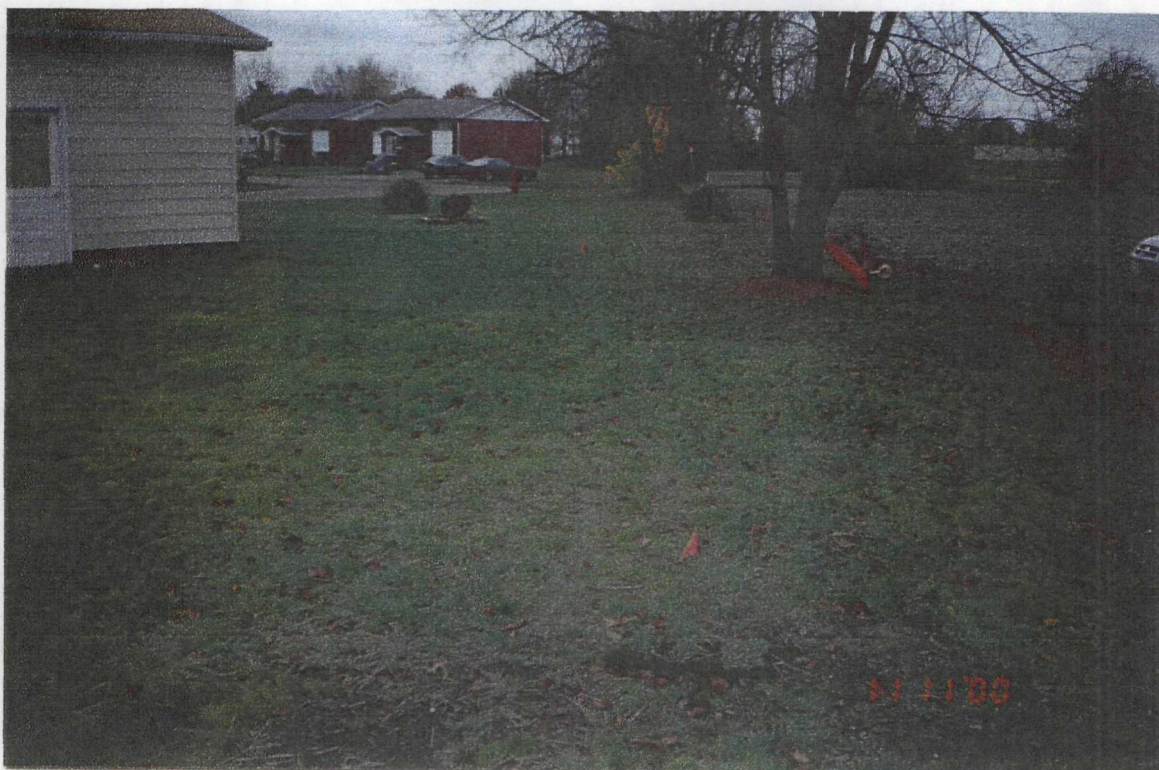
SITE: Bowers Battery **TDD:** S05-0010-022 **PAN:** 0C2201SIXX **PHOTO:** 19
DATE: November 11, 2000 **DIRECTION:** Northwest **PHOTOGRAPHER:** D. Pearce
SUBJECT: View of the northwest transect (sampling locations NW-01, NW-02, and NW-03) which runs from BB-RS-24 to the survey stake for the property corner of 467 5th Street NW. This transect is approximately 126 feet in length.

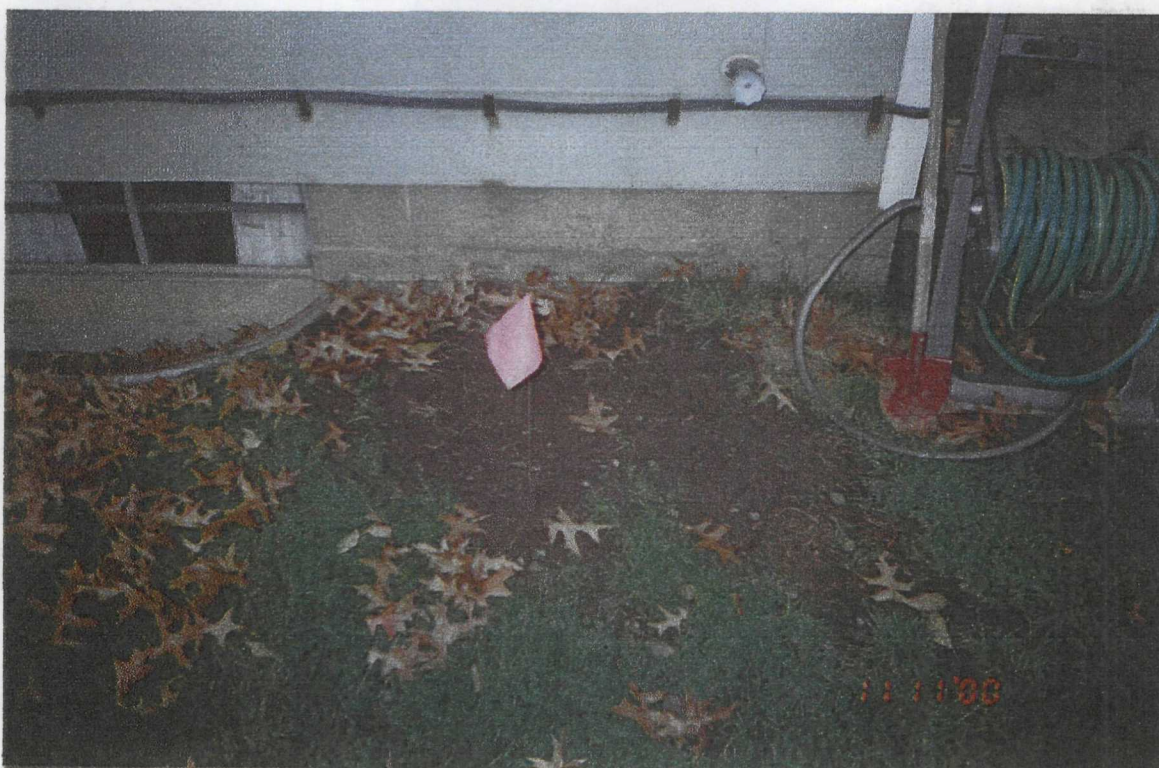
SITE: Bowers Battery **TDD:** S05-0010-022 **PAN:** 0C2201SIXX **PHOTO:** 20
DATE: November 11, 2000 **DIRECTION:** West **PHOTOGRAPHER:** D. Pearce
SUBJECT: View of soil sampling location BB-F-01 in the back yard of 463 5th Street NW at the house foundation between the basement window well and the rear door/patio.

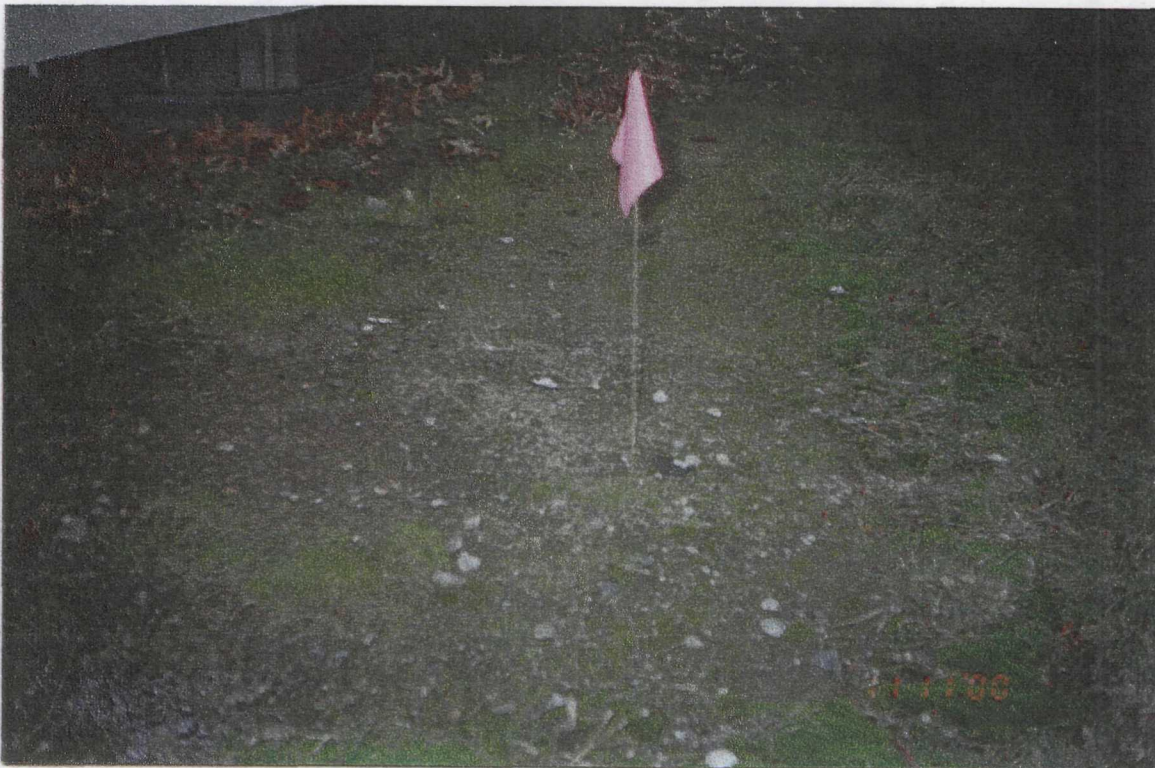
SITE: Bowers Battery **TDD:** S05-0010-022 **PAN:** 0C2201SIXX **PHOTO:** 21
DATE: November 11, 2000 **DIRECTION:** Northwest **PHOTOGRAPHER:** D. Pearce
SUBJECT: View of soil sampling location BB-F-02 in the back yard of 467 5th Street NW at the house foundation between the downspout from the gutter and the basement window well.

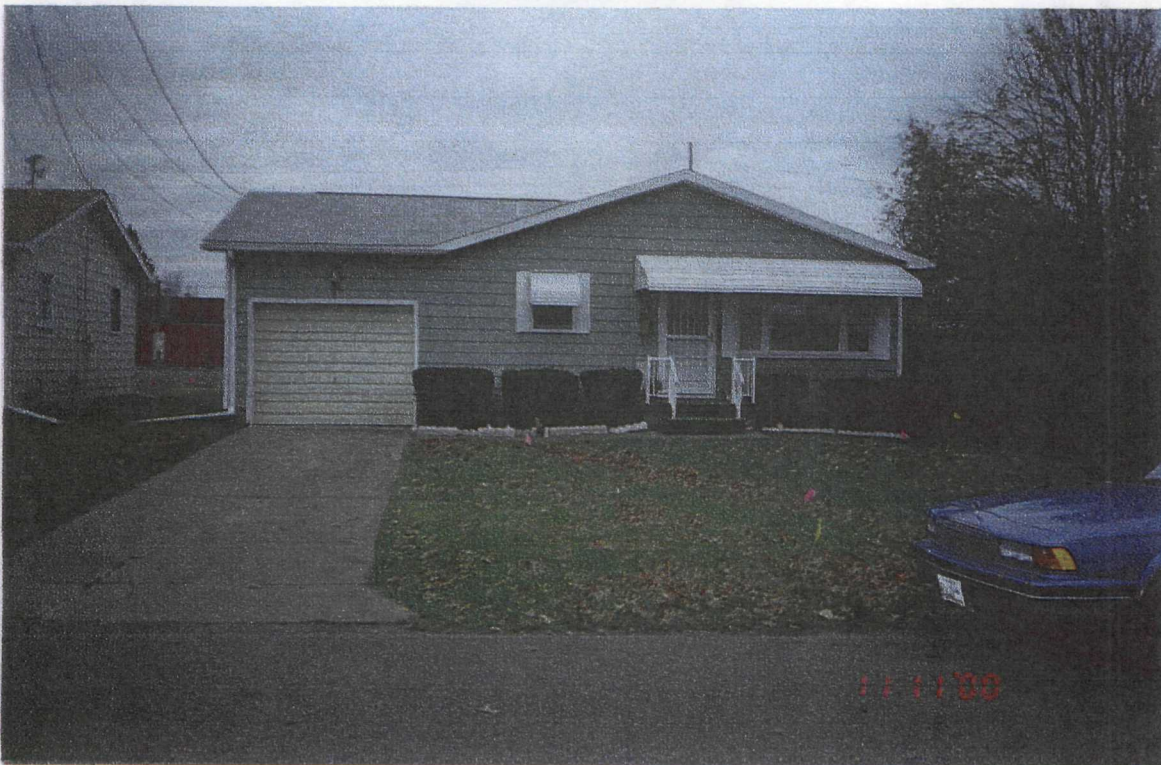
SITE: Bowers Battery **TDD:** S05-0010-022 **PAN:** 0C2201SIXX **PHOTO:** 22
DATE: November 11, 2000 **DIRECTION:** East **PHOTOGRAPHER:** D. Pearce
SUBJECT: View of the front yard of 463 5th Street NW (sampling locations RS-43, RS-44, and RS-45).

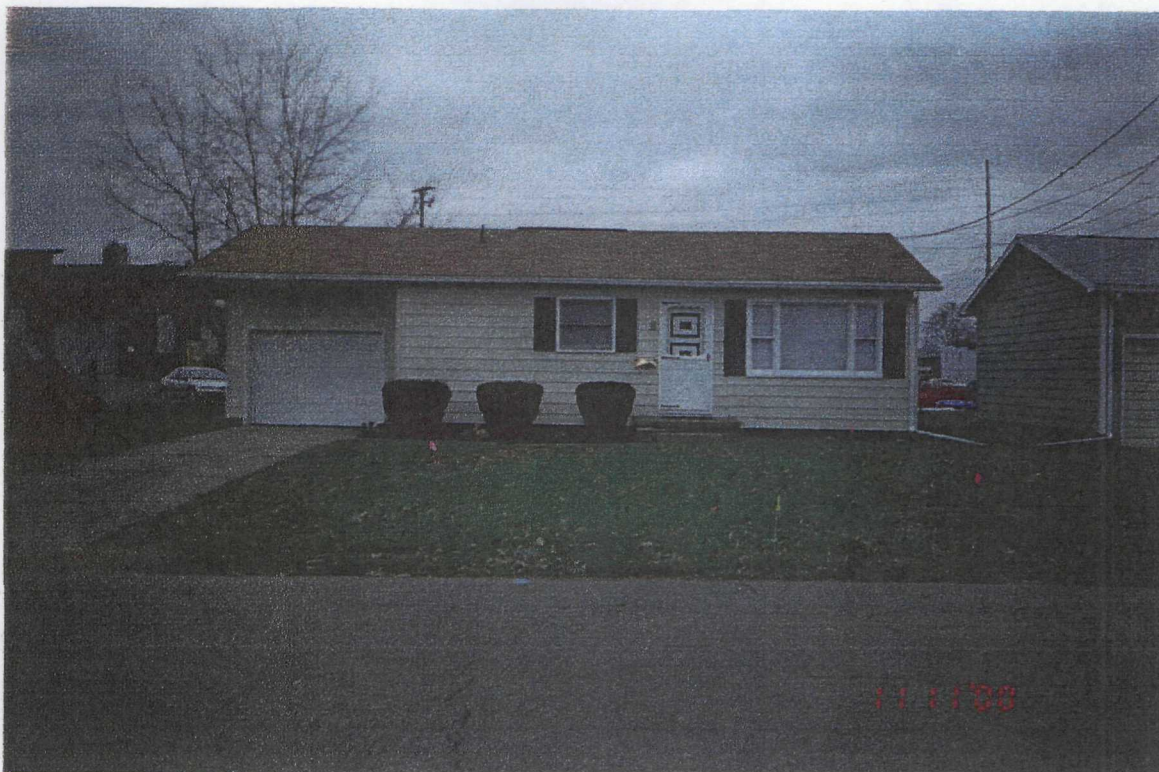
SITE: Bowers Battery **TDD:** S05-0010-022 **PAN:** 0C2201SIXX **PHOTO:** 23
DATE: November 11, 2000 **DIRECTION:** East **PHOTOGRAPHER:** D. Pearce
SUBJECT: View of the front yard of 467 5th Street NW (sampling locations RS-40, RS-41, and RS-42).
